Nasca earthquake, November 12, 1996, Peru

J.E. Alva Hurtado & D. Vasquez Lopez
CISMID, National University of Engineering, Lima, Peru

ABSTRACT: The main features of the November 12, 1996 earthquake produced in the Nasca region in southern Peru are presented. A summary of damage evaluation and seismic microzonation undertaken by several national and international institutions is also presented.

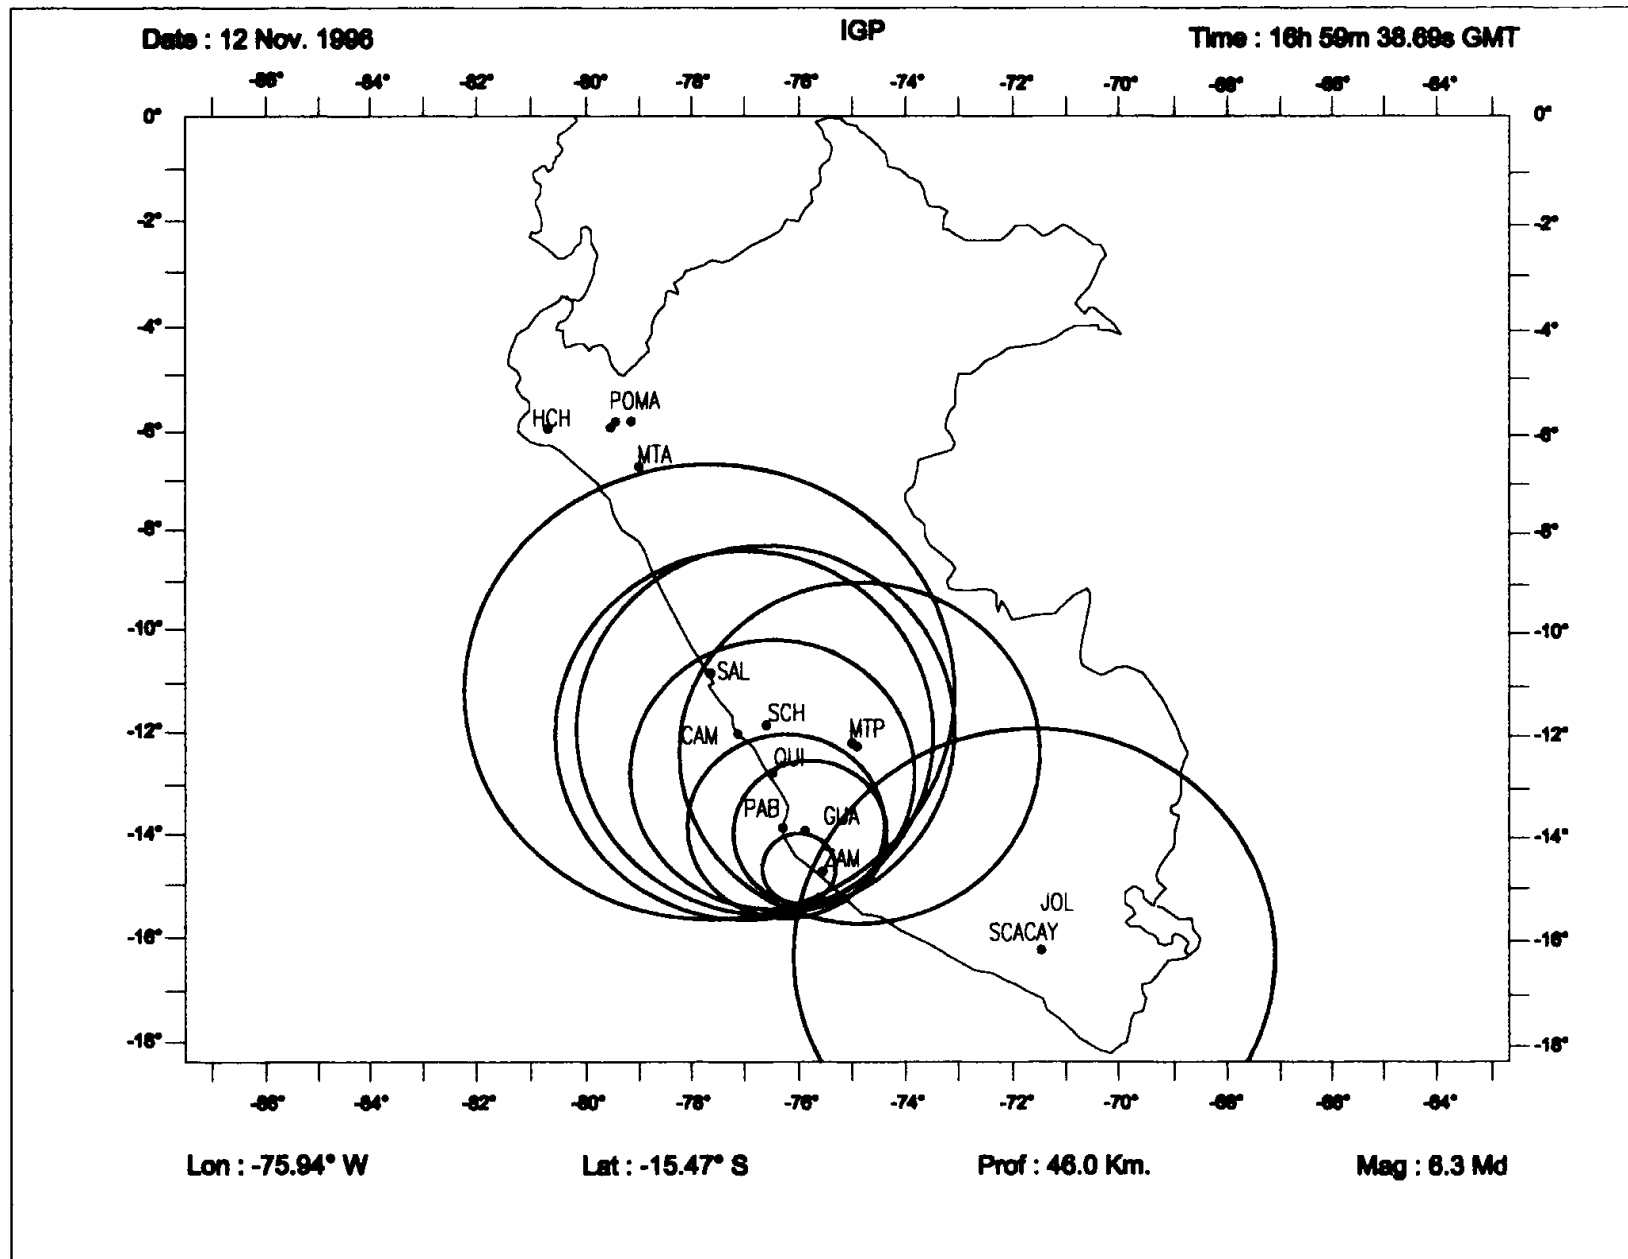
FIGURE N°1 : EPICENTER OF NOVEMBER 12, 1996 NASCA EARTHQUAKE (IGP, 1997)

75.68°W. Figure 1 presents IGP's epicentral calculation.

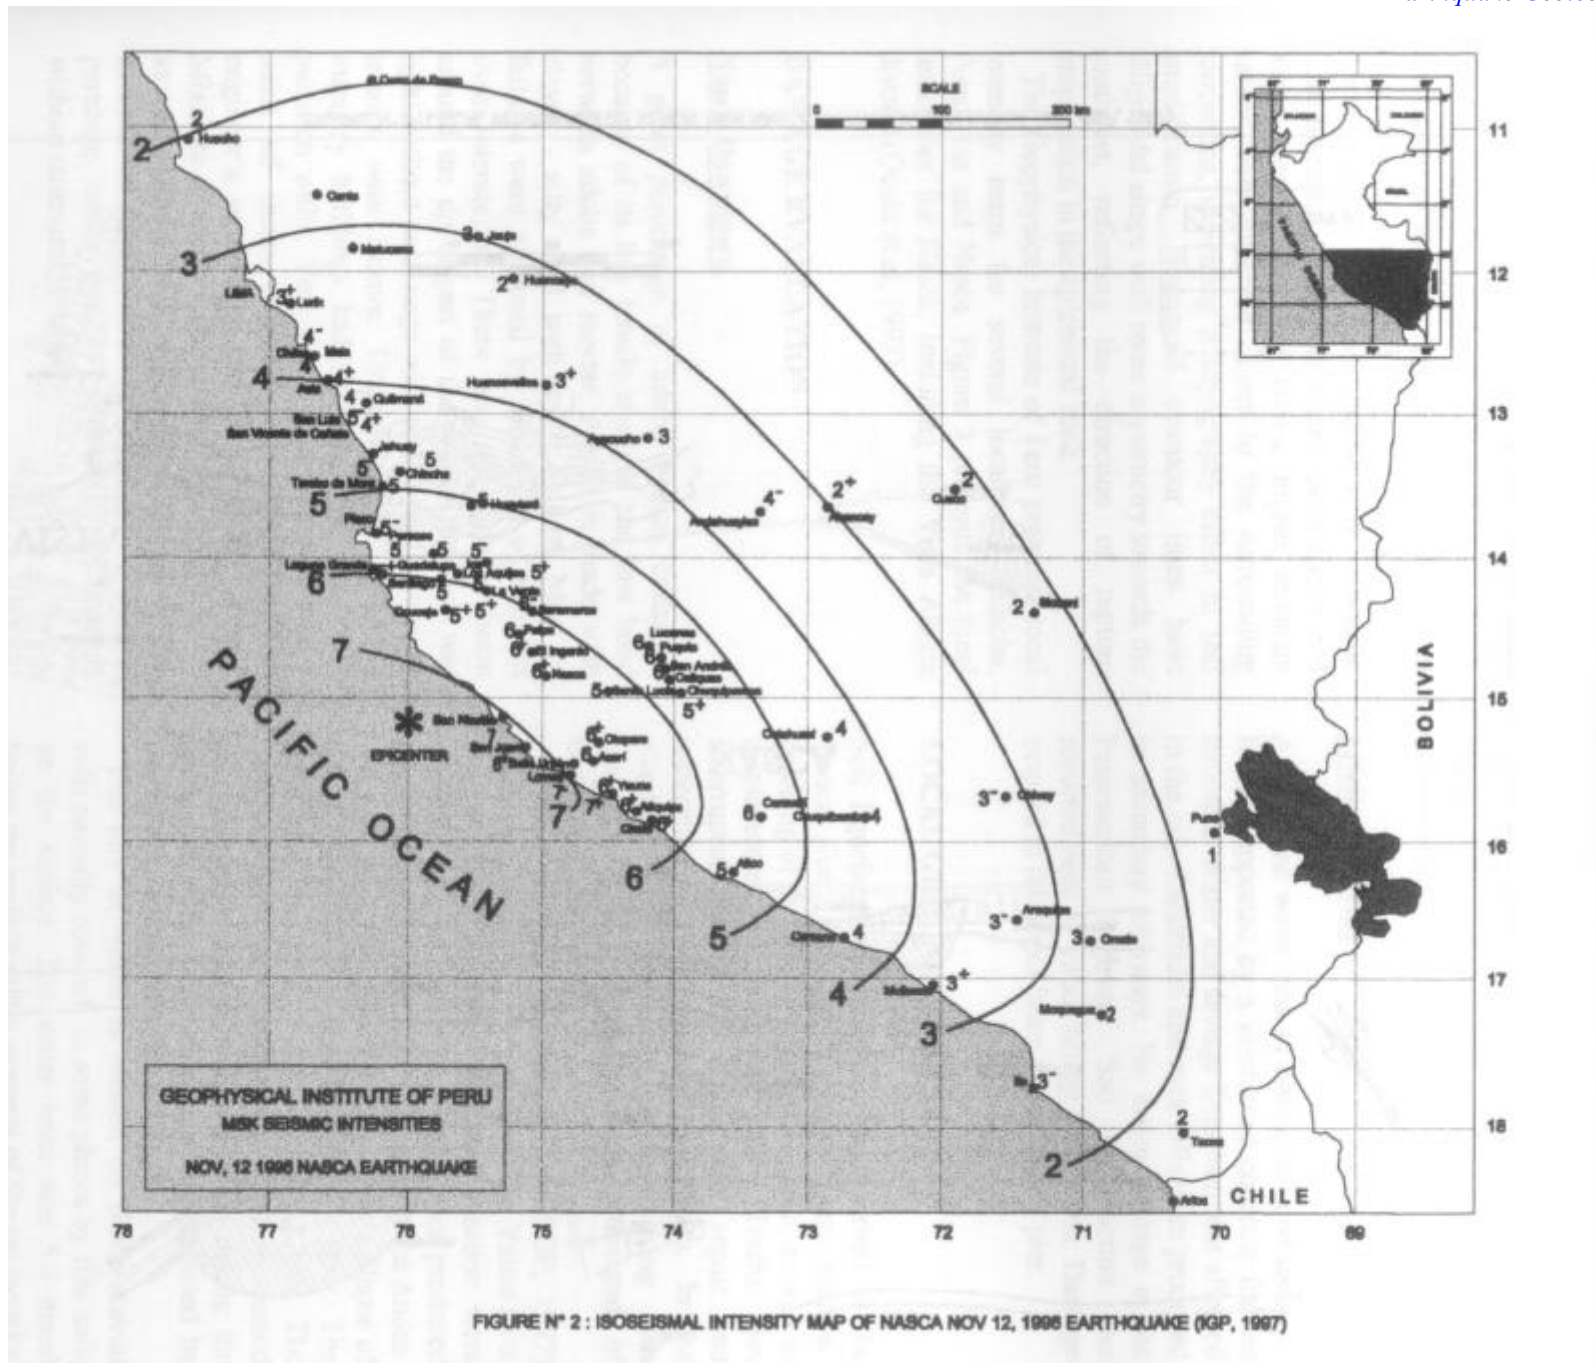
A regional intensity map, MSK scale (Figure 2) for the November 12, 1996 earthquake was presented by the Geophysical Institute of Peru (Ocola et al, 1997).

The maximum intensity of 7⁺ (MSK scale) was observed in the Yauca river estuary. Along the shore line between Yauca and San Nicolas, cracks were observed as well as along the shoulders of the adjacent Panamerican Highway. Soil liquefaction

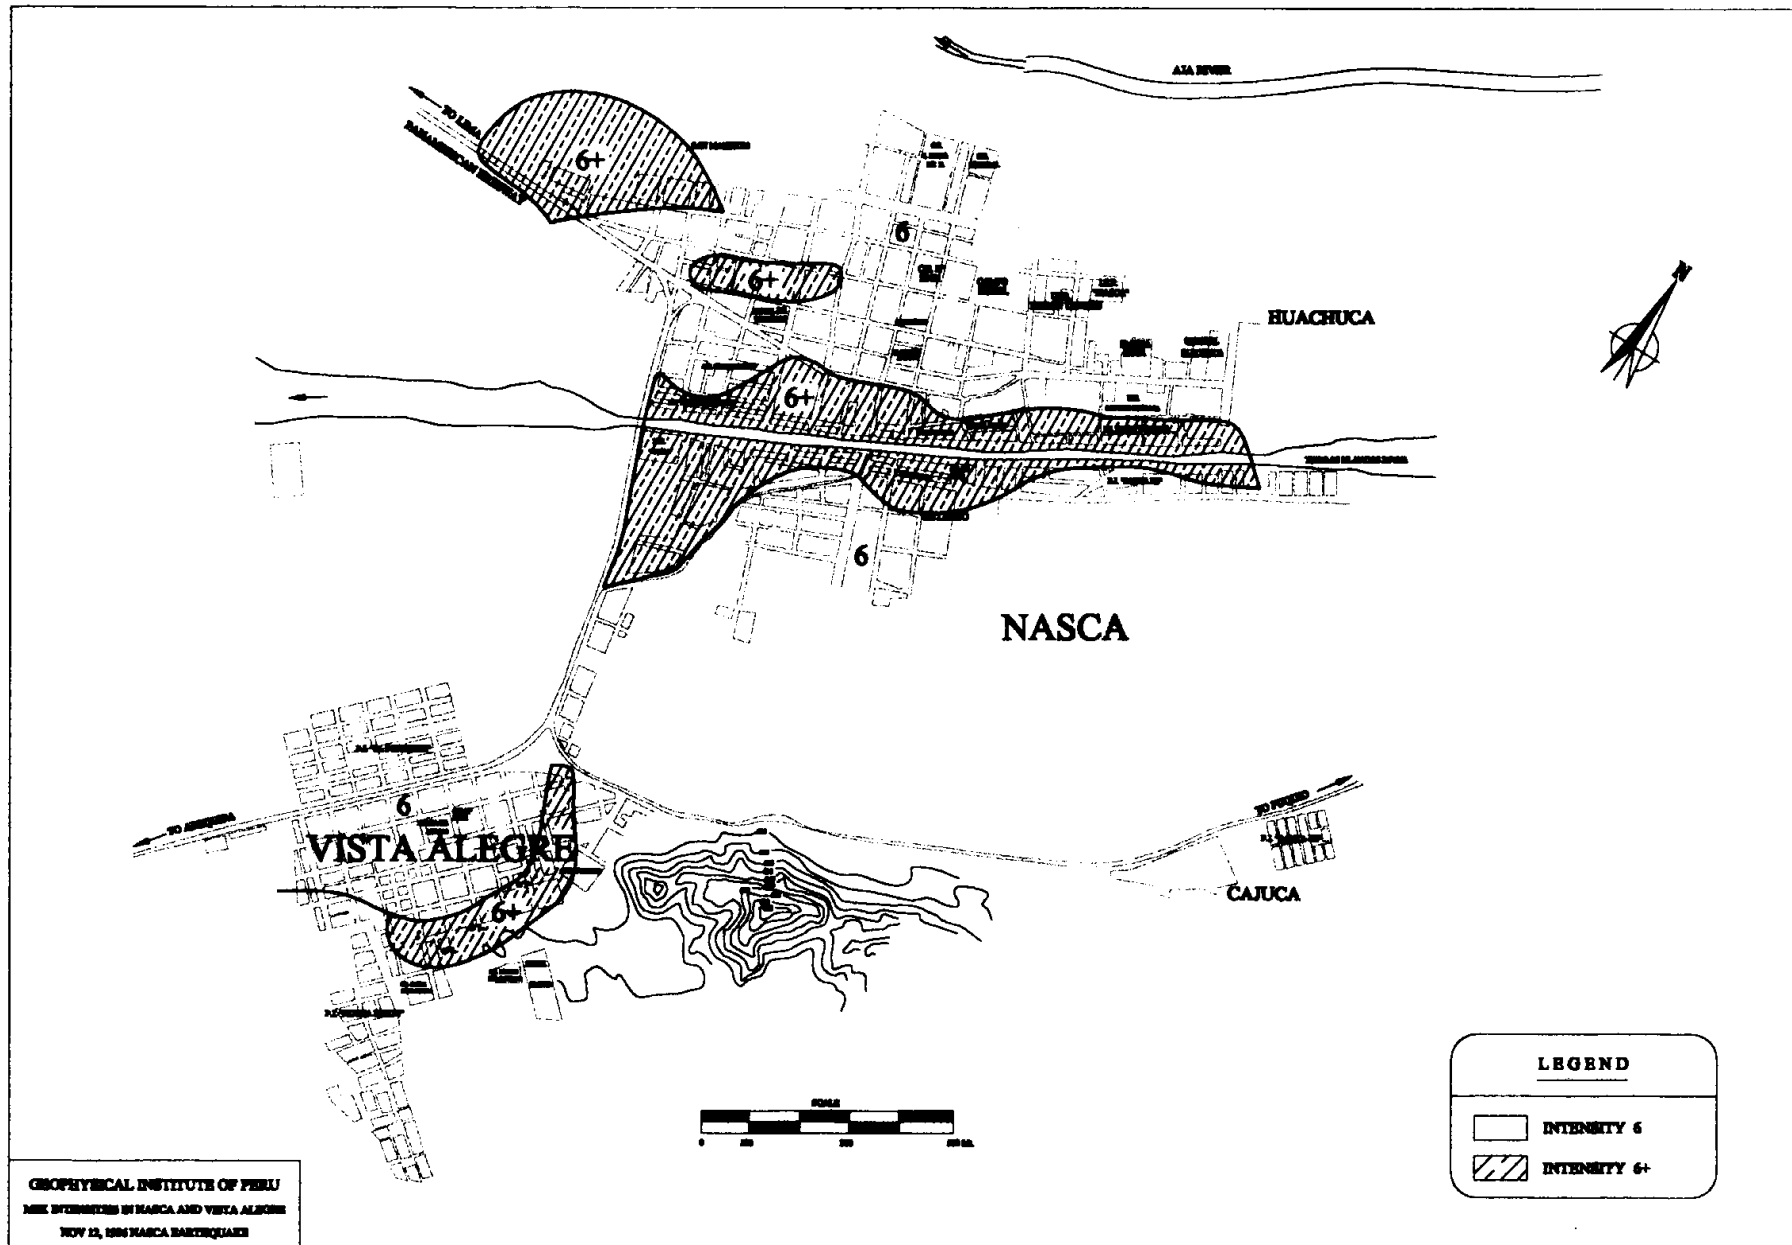
FIGURE N° 3 : LOCAL INTENSITIES OF 12 NOV 1986 NASCA EARTHQUAKE IN NASCA CITY (IGP, 1987)

The Geophysical Institute of Peru prepared local intensity maps for several localities: Chíncha, Pisco, Ica and Nasca. Figure 3 presents the local intensities for Nasca, including the Vista Alegre district (Ocola et al, 1997).

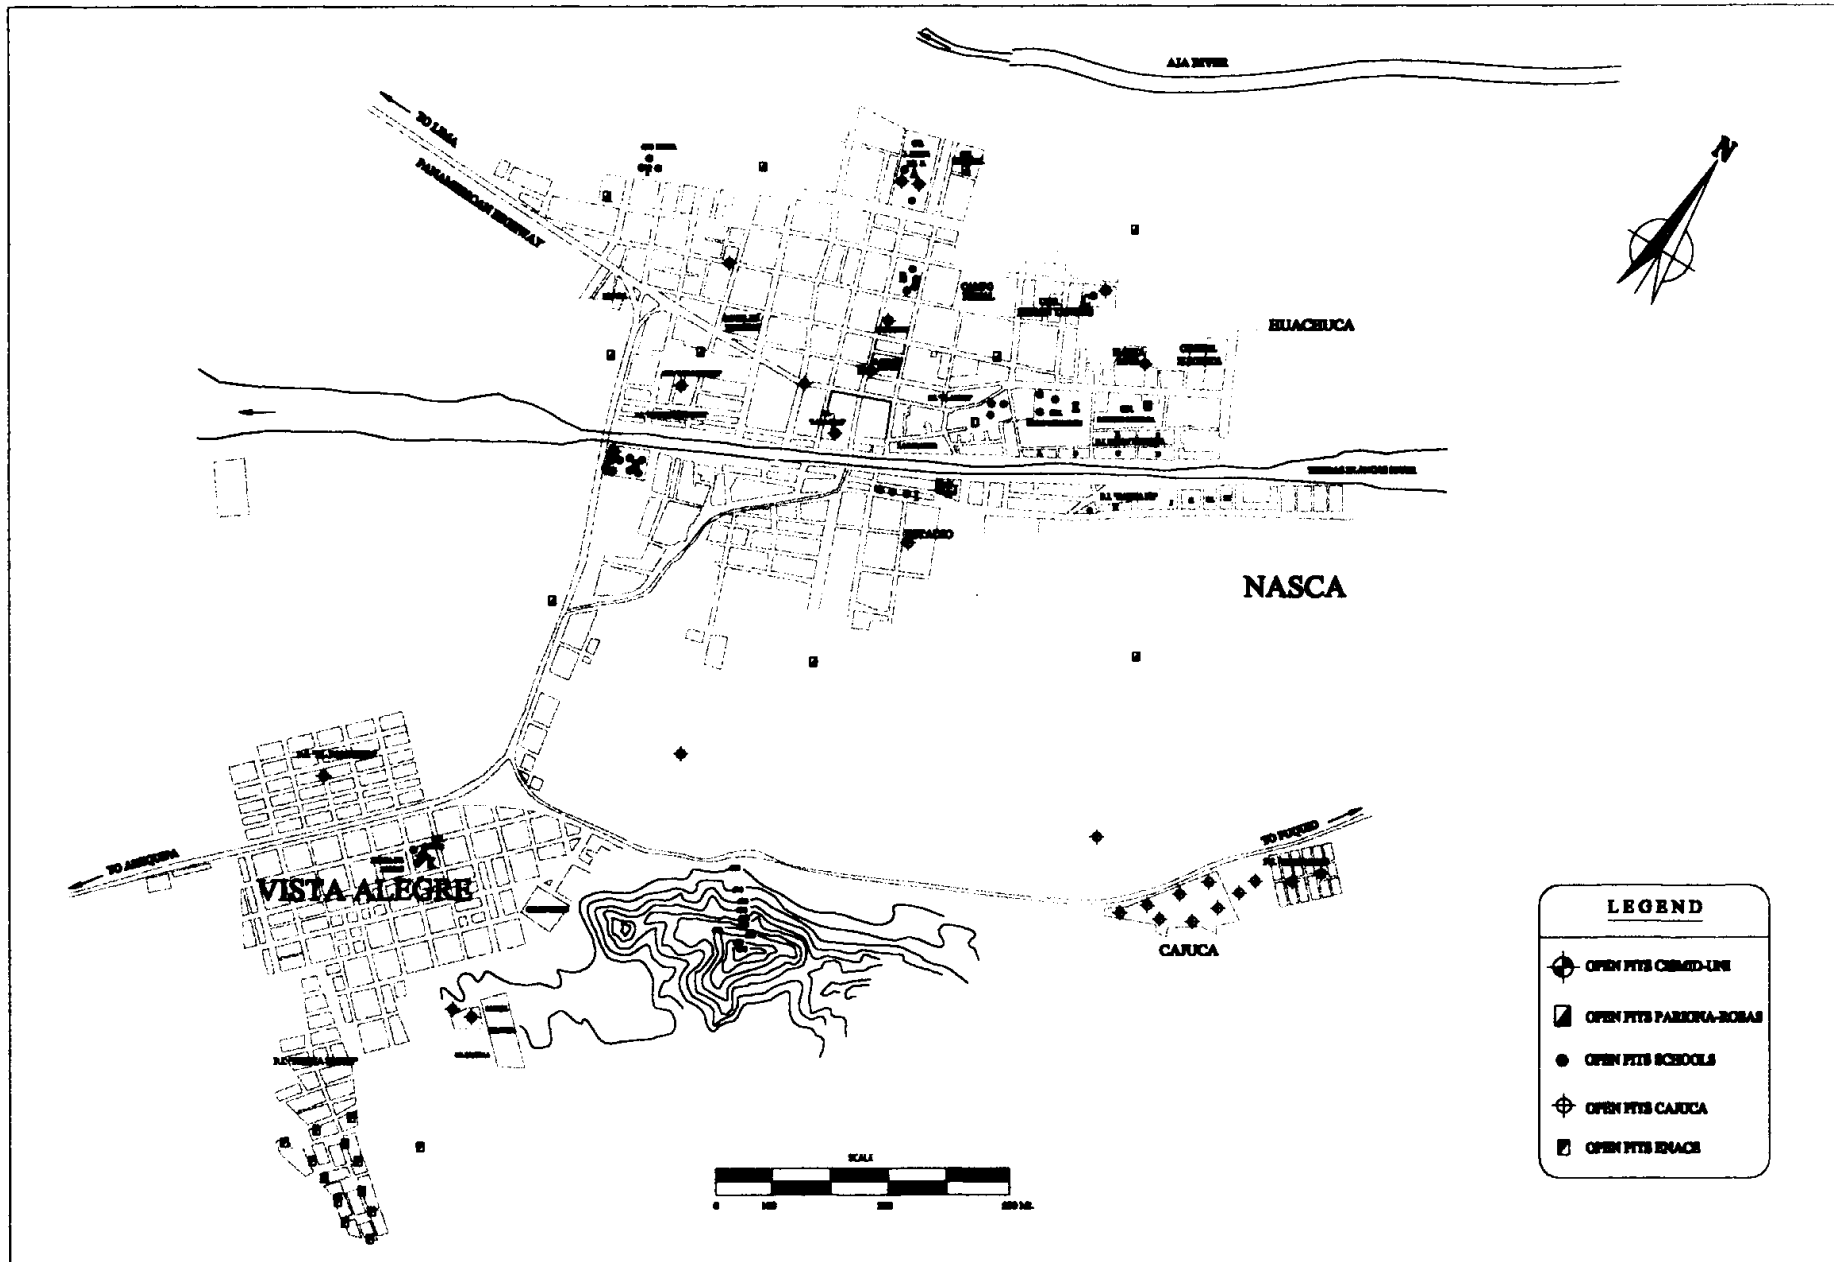
FIGURE N° 4 : SOIL EXPLORATION PROGRAM FOR NASCA MICROZONATION

Figure 4 present the location of open pits compiled and executed in Nasca and Vista Alegre. Because of the nature of the ground, hand made open pits up to 5.0 meters in depth were made. Figure 5 presents the locations of the microtremor measurements and their natural periods under ambient vibration.

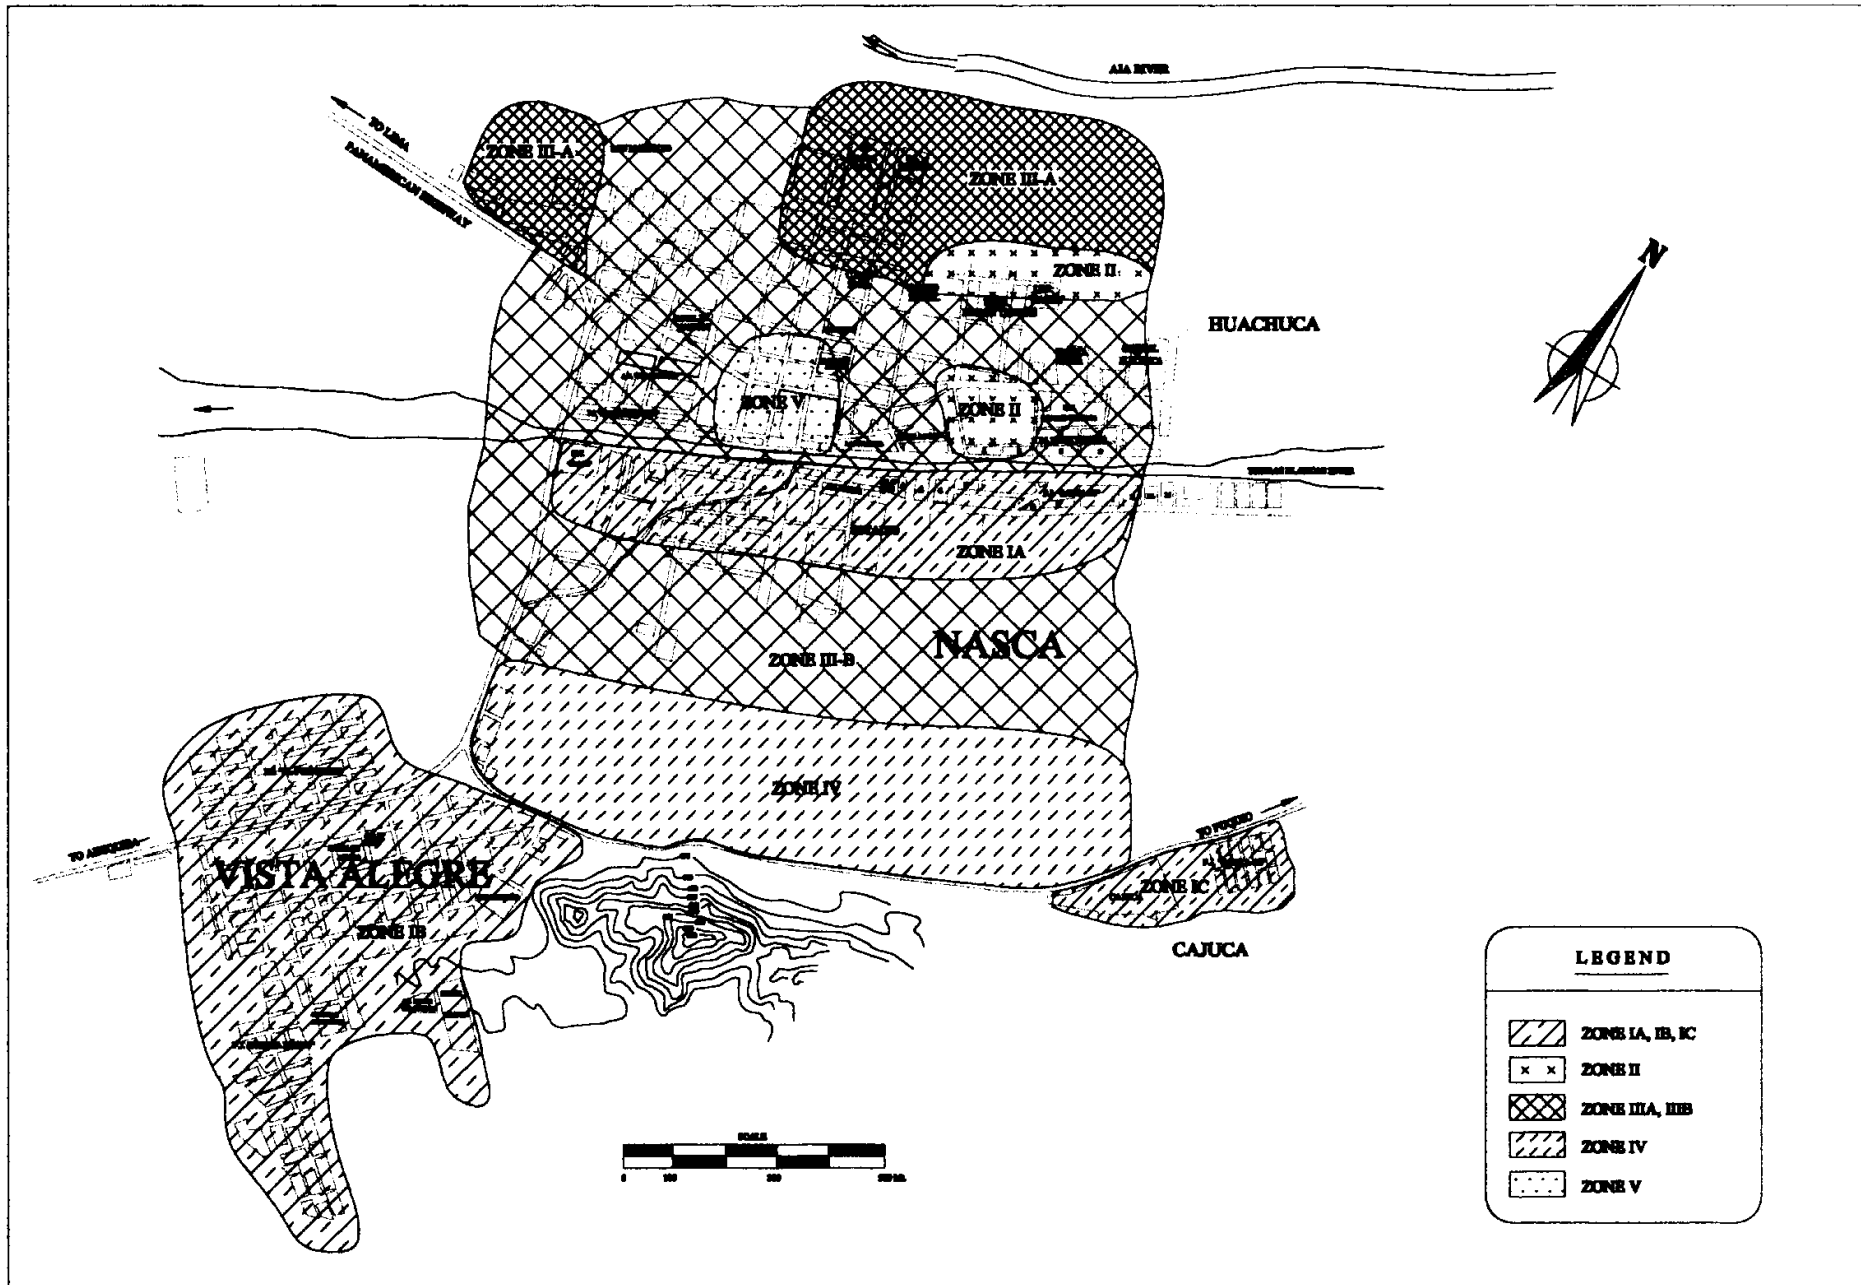
FIGURE N° 6 : SEISMIC MICROZONATION OF NASCA CITY (Vásquez and Alva-Hurtado, 1987)

The city was divided into five zones as presented in Figure 6.

Zone I. This zone has the best geotechnical conditions. The ground is composed of compacted gravel with boulders up to 10" in diameter. Bearing capacity is over 2 kg/cm² and the predominant period of soils is between 0.1 and 0.2 seconds. This zone was subdivided in 3 subzones.

Zone II. This zone is similar to zone I, with gravel down to 1.5 meters in depth. Fine material exists at the surface. Bearing capacities are from 1.5 to 2.0 kg/cm² and the predominant periods of soils are from 0.20 to 0.25 seconds.

Zone III. A medium thick layer of fine soils exists at the surface. Below the superficial layer, the gravel layer appears. For shallow foundations settlements are expected. It is recommended to reach the gravel layer for founding important buildings. Bearing capacities range from 1.0 to 1.5 kg/cm² and soil predominant period varies from 0.25 to 0.40 seconds.

Zone IV. The superficial layer consists of silty and clayey soils with thickness greater than 5.0 meter. The gravel layer is located beneath this layer. Bearing capacity of 1.0 kg/cm² is expected for shallow foundations. Predominant period is greater than 0.4 seconds. This zone is not developed. Soil amplification is expected because of the presence of nearby mountains.

Zone V. This is a critical zone because there is loose thick fill on the surface. This area is near Nasca downtown where adobe houses collapse was total during the earthquake. It is recommended to use this area for public recreation and parks.

- 4) Future development of Nasca is recommended towards zones I and II, where the ground is composed of compact sandy gravel. Flood protection structures along the river banks should be provided. Zone III has second priority because the gravel layer is deeper.

- 5) Zone IV and V are critical because the gravel is below 5.0 meters. Zone IV is close to the nearby mountains and could develop soil amplification. Zone V has loose fill at the surface providing weak foundations.
