**REPORT ON  
SEISMIC MICROZONING OF  
CHIMBOTE AREA  
PERU**

**MARCH 1971**

**OVERSEAS TECHNICAL  
COOPERATION AGENCY  
— GOVERNMENT OF JAPAN**

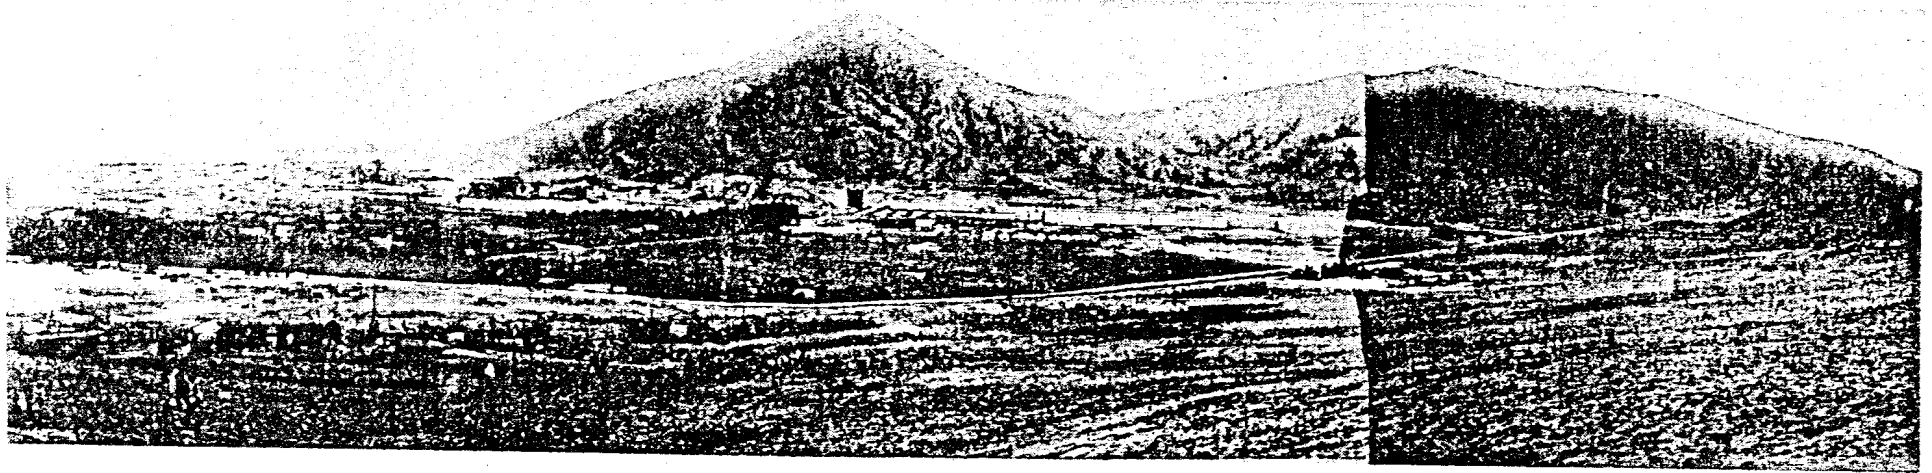
Fig. 2-4  
Sand dunes and the  
Rio de Lacramarca  
alluvial plain  
(southern Chimbote)

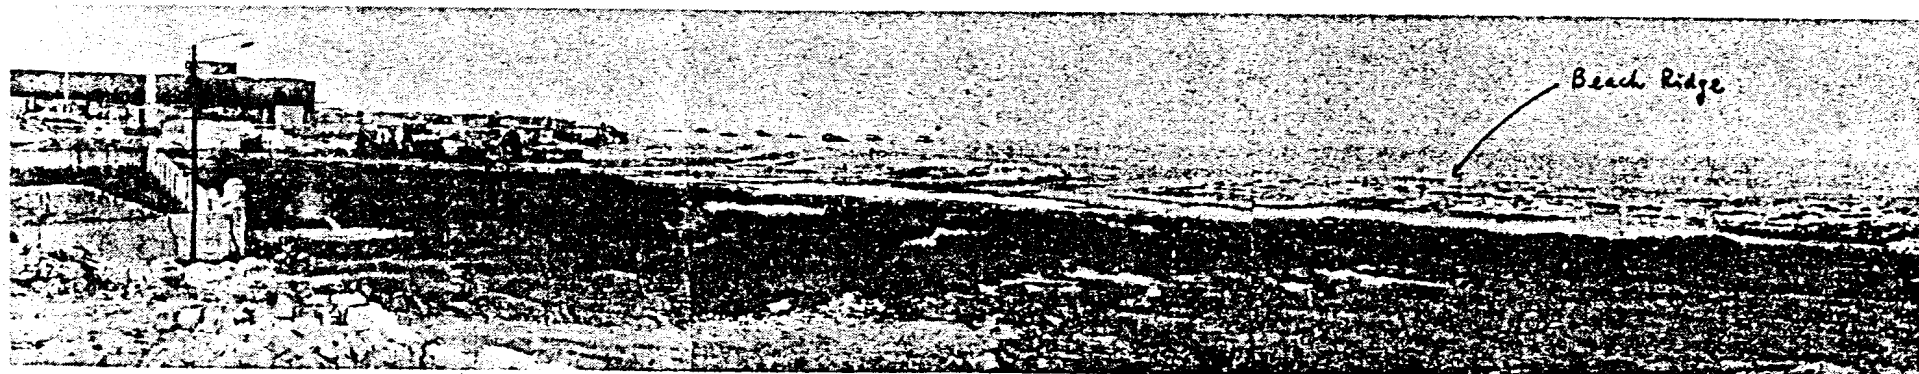
Fig. 2-6  
Backswamp and sand  
dunes  
(southern Chimbote)

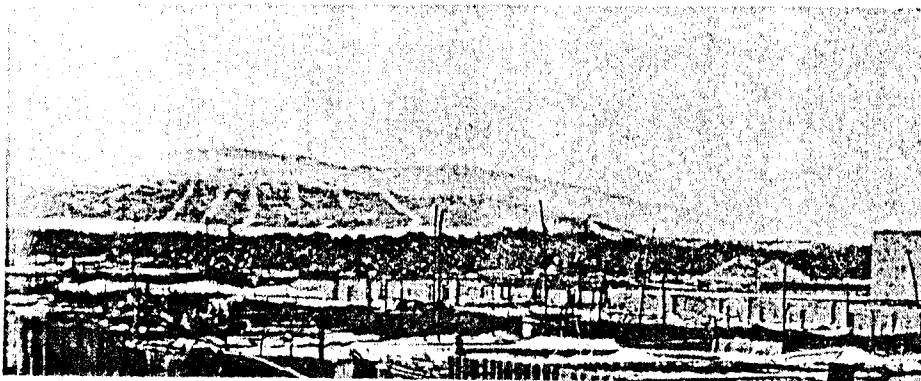
Fig. 2-12  
Southern slope of  
Co Tambo Real,  
covered largely  
by old eolian sand. *Barrio*  
Houses on the slope  
are Barrio San Pedro.

slope (Fig. 2-12). The sand consists of fine to coarse sands containing small fragments of shells. The thickness is not known, but it is estimated at less than a few meters in thickness. Beneath the loose sands, semi-consolidated sand layers are exposed on steep slopes or cliffs, which are cross-bedded and more than a few meters thick. The sand layers consist of fine to coarse sands with shell fragments. The calcareous matter is served as cement. The superficial loose sands and the underlying semi-consolidated sands mentioned above are very similar to each other. The both sands are considered as old eolian sands (or beach sands reworked by wind) which were formed when the coastal line was situated more closely to the foot of these hills than the present situation. This seems reasonable from the fact that well-preserved beach ridges lie in the area between this sandy hill and the present coastal line and that the coarse sand and larger fragments of shell are commonly included in the deposits.

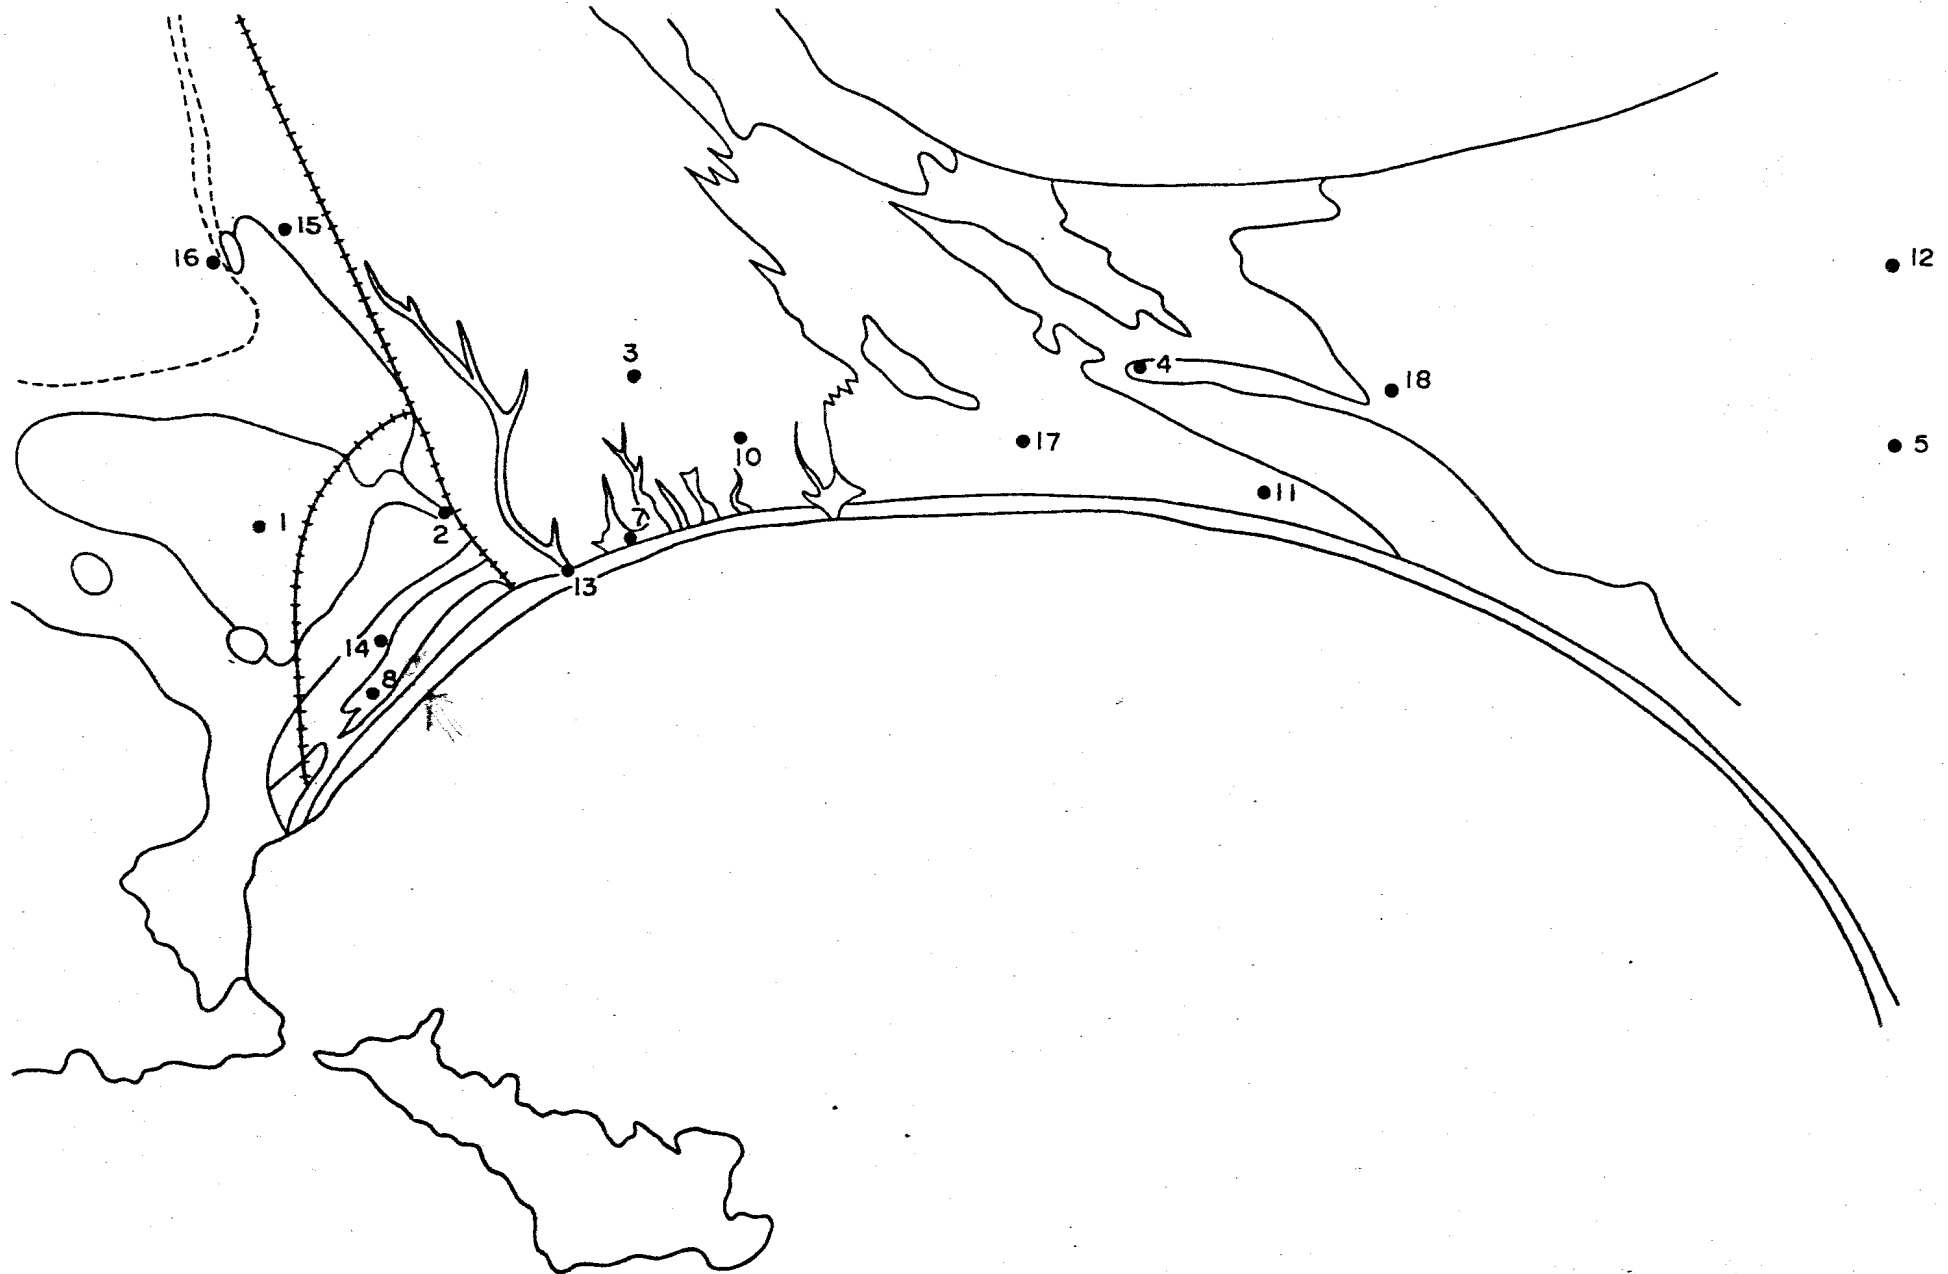
Fig. 3-1 LOCATION OF BORINGS *Penetecr Stador*

To investigate the subsoil conditions, records of pre-existing borings and water-well as much as available were examined, and a total of 16 borings were made at locations as shown in Fig. 3-1. Depths of most of them were about 25 m below the ground surface. The penetration test was accompanied every one meter in each of the boreholes, counting the number of blows  $N'$  necessary for the split spoon sampler with an outer diameter of 2.5 in. to produce the penetration of a foot under the repeating impact of 210 lb x 20 in. Later,  $N'$ -values obtained by this method were compared with  $N$ -values for the standard penetration test (2 in. split spoon sampler), and it has been found that the good correlation of  $N=0.88 N'$  exists between them (Appendix 1). Additionally, hand borings were made with an auger down to depths of about 3 m to investigate the surface soil conditions and the water table. Grain size analysis was also conducted for some of samples taken by the spoon sampler (Appendix 3).

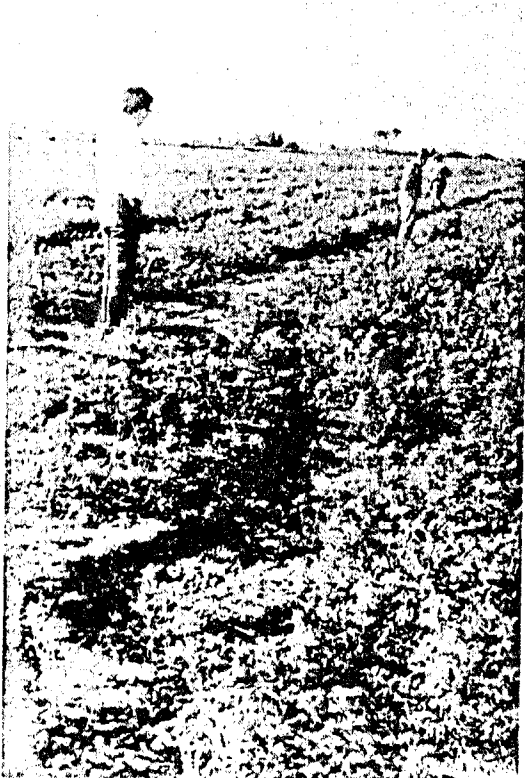
Fig. 8-4  
Open cracks associated with Sand volcanoes (Loc. same as Fig. 2 )

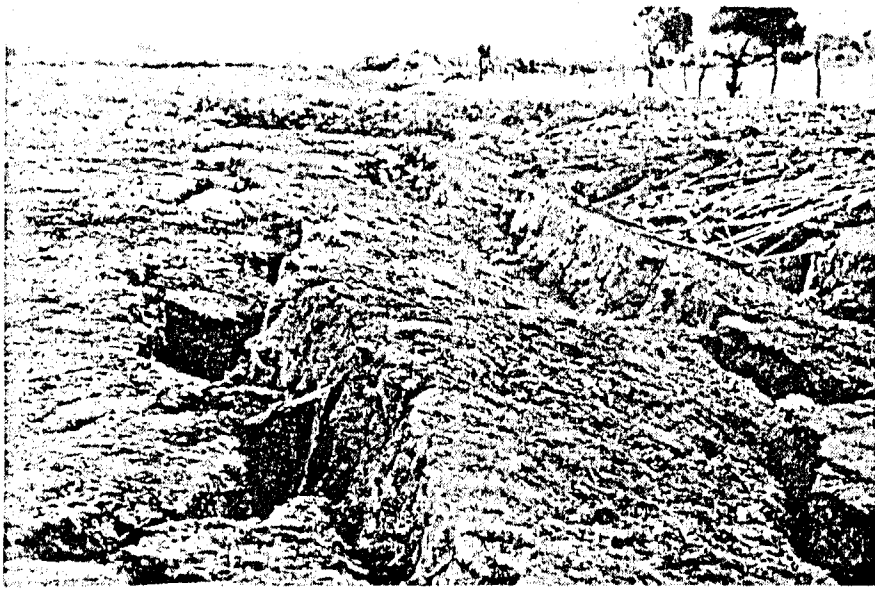
Fig. 8-5  
Ground cracks on the  
Rio de Lacramarca  
alluvial plain.  
(Hda. San Jose)

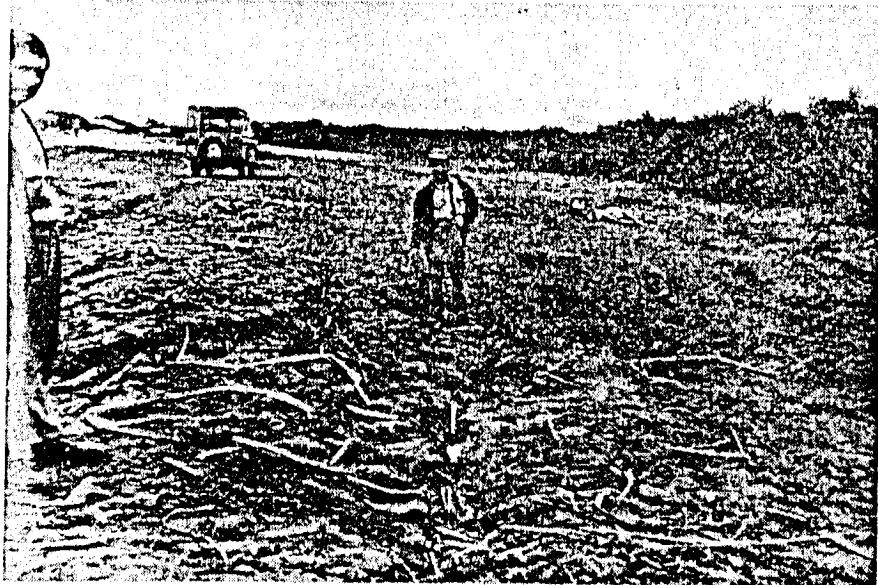
Fig. 8-8  
Cracks near the  
boundary between  
sand dune and  
backswamp  
(Tres Cabezas)

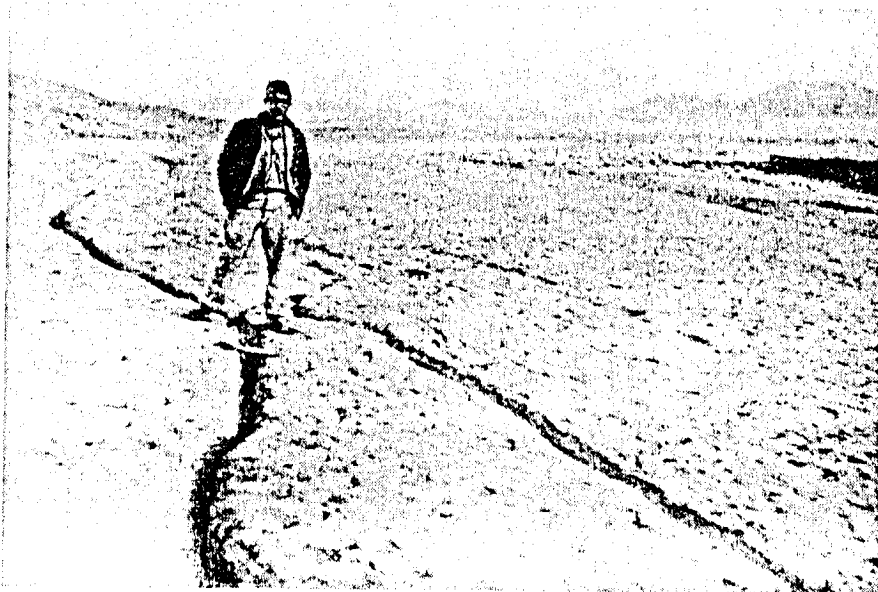
Fig. 8-9  
Cracks in the crust  
of semi-consolidated  
sand layers on the  
hill slope of San  
Pedro

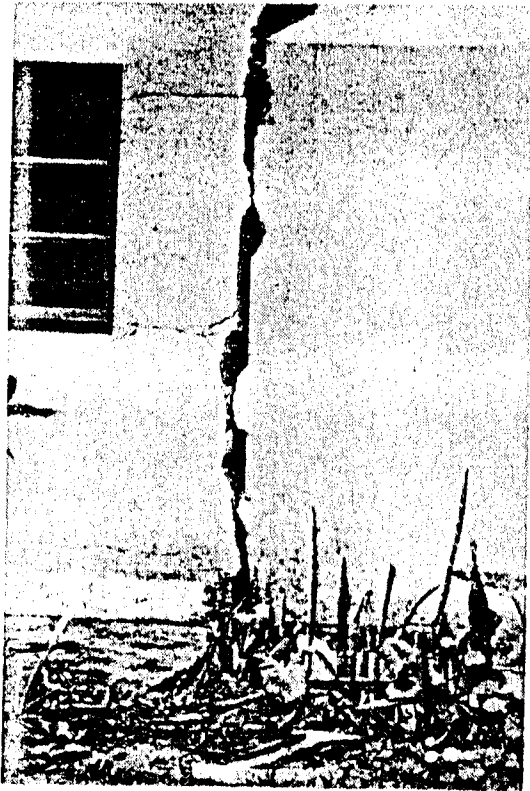
Fig. 8-13  
Damage to houses  
due to differential  
subsidence of the  
ground at the edge  
of beach ridge.  
(a, b: Urbanizacion  
la Caleta,  
c: Urb el Trapecio)

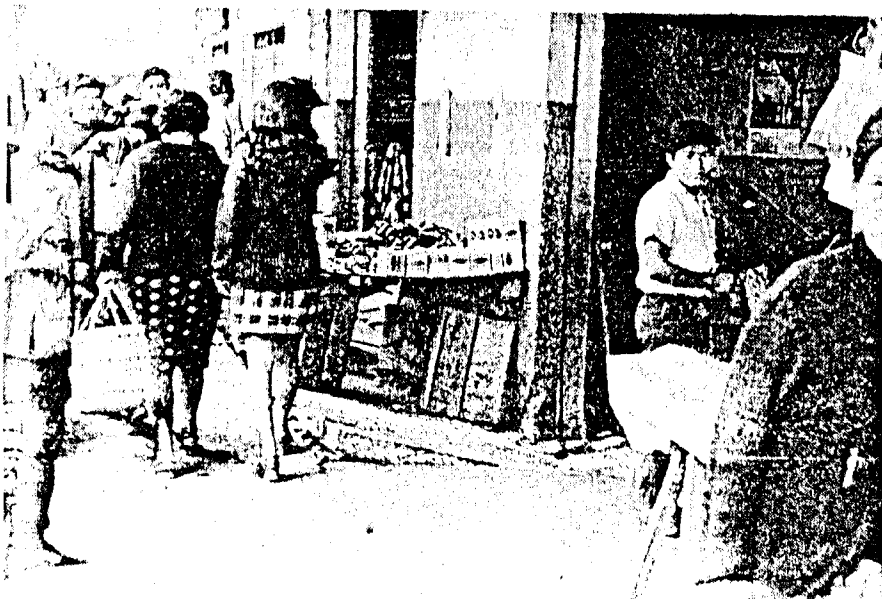
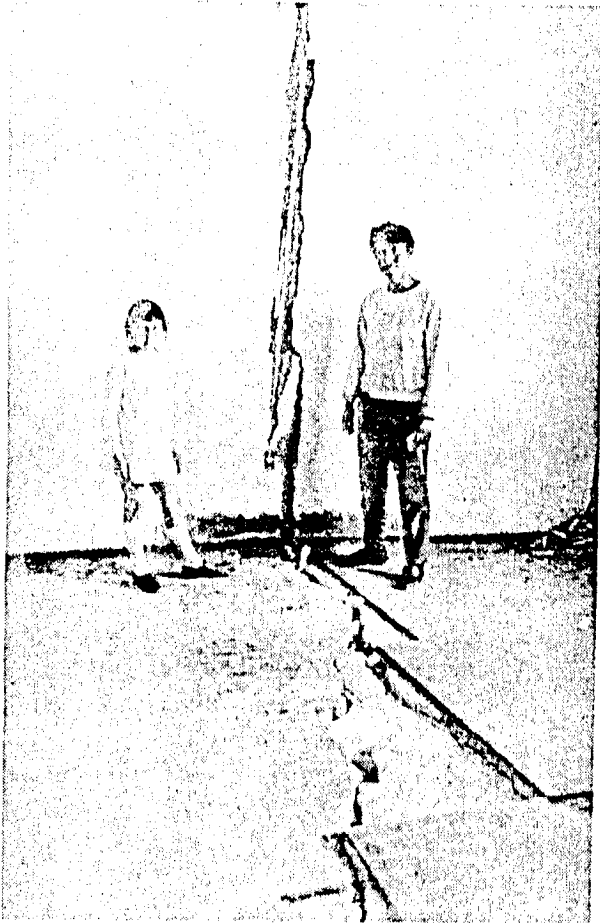
**Fig. 8-18**  
**Damage to house**  
**due to differential**  
**subsidence.**  
**(Casco Uabano)**

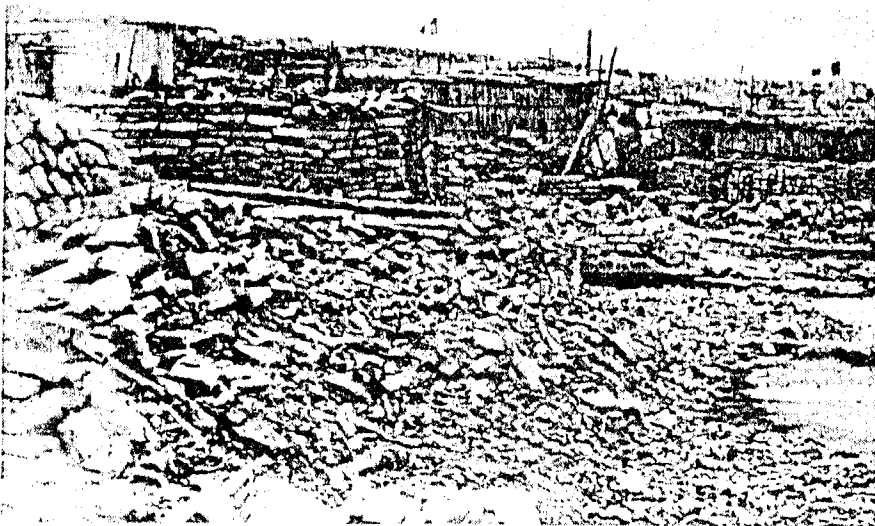
Fig. 8-19  
Damage to building  
due to earthquake  
shocks.

- (a: Miraflores,
- b: School
- building of G.U.E.
- Inmacu lada de la
- Merced,
- c: San Pedro)
