# Confined and Reinforced Sand Retaining Walls resisted VIII Grade Seismic MM Intensity.

**Keywords:** IGCS (Indented Geocellular Confined System), Confined & Reinforced Sand Retaining Walls, Seismic Events

This paper describes a Sand Banks Stabilization Project at Cerro de Arena, located in the South Pan-American Highway, 715+000 to 774+000 Km., between Atico and Ocoña close to Arequipa, Peru.

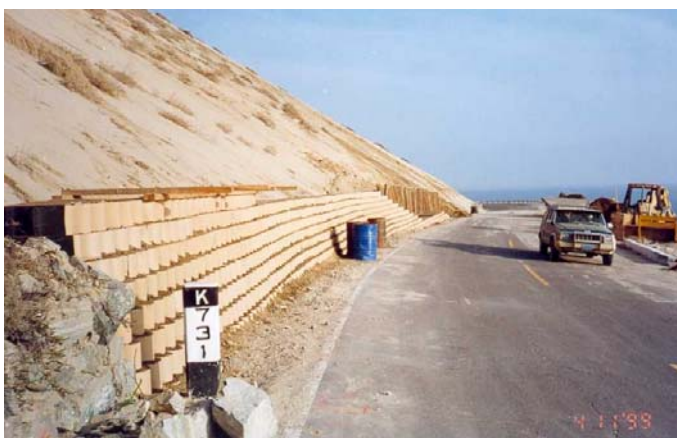
The structure shown in the picture corresponds to a wall of 250m of long located in the km 731+000.

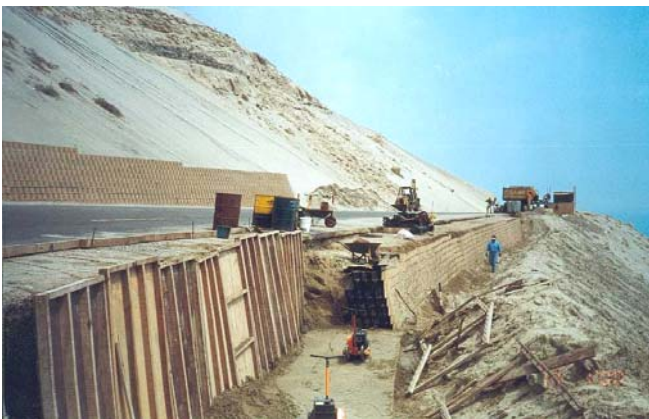
The face and top of the structure had a fill material with uniform gravel no more than 2"; to avoid piping problems and sand washing.

It was clear that the structure is a good drainage system by itself and provides good flexibility for what is not necessary a parallel drainage system, neither the use of construction joints.
